ST PAUL'S BOW COMMON

Urgent Repairs Project – HLF Development Stage

Outline Schedule of Works for Tender | Document Ref: 201407-500 | **Rev 4** | **29 December 2014**

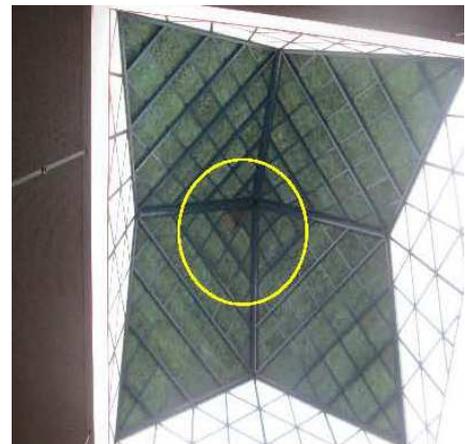
This urgent repair project was conceived as a direct response to the partial collapse of the ceiling linings to the lantern over the central High Altar at St Paul's Bow Common, which occurred on a very hot July day in 2013.

Figure 3. Location of wood wool ceiling panels which fell from the high level lantern in July 2013

3.1	<p>OPTION A: Subject to further evaluation once all wood wool panels can be removed and tested 'Retain as much of the original wood wool as possible'</p> <p>Carry out joint inspection of existing wood wool slabs with Architect and schedule all panels to be removed and replaced due to inadequate bearing, friable edges to wood wool panels and/or excessive deflection across the panel width.</p> <p>Assume 15% replacement and record the location of all new panels. However, if site testing reveals that replacement of more than 35% of the existing wood wool is required, it will be more cost-effective to replace all the wood wool, and OPTION B will apply.</p> <p>NOTE: All existing woodwool panels are to be carefully removed in sequence from the lantern apex down to the eaves. Working with 1 structural bay at a time, one 'diamond' at a time, to label and set-aside panels in sequence to ensure they are returned to the correct location upon reinstatement. Contractor to prepare a method statement for comment prior to commencement of any works.</p> <p>As part of testing prior to reinstatement, weigh down each wood wool</p>	<p>Drawing 201409-120 + 121</p>

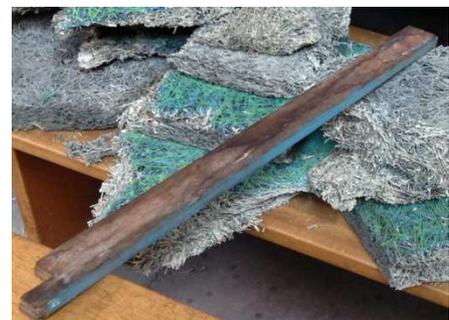
Figure 4. Fragments of wood wool and plywood battens recovered from the collapsed section of the ceiling
